Leicester Middle School  
70 Winslow Avenue  
Leicester, MA 01524

AHERA Three-Year Reinspection

April 2019

PROJECT: AHERA 3-Year Re-Inspection

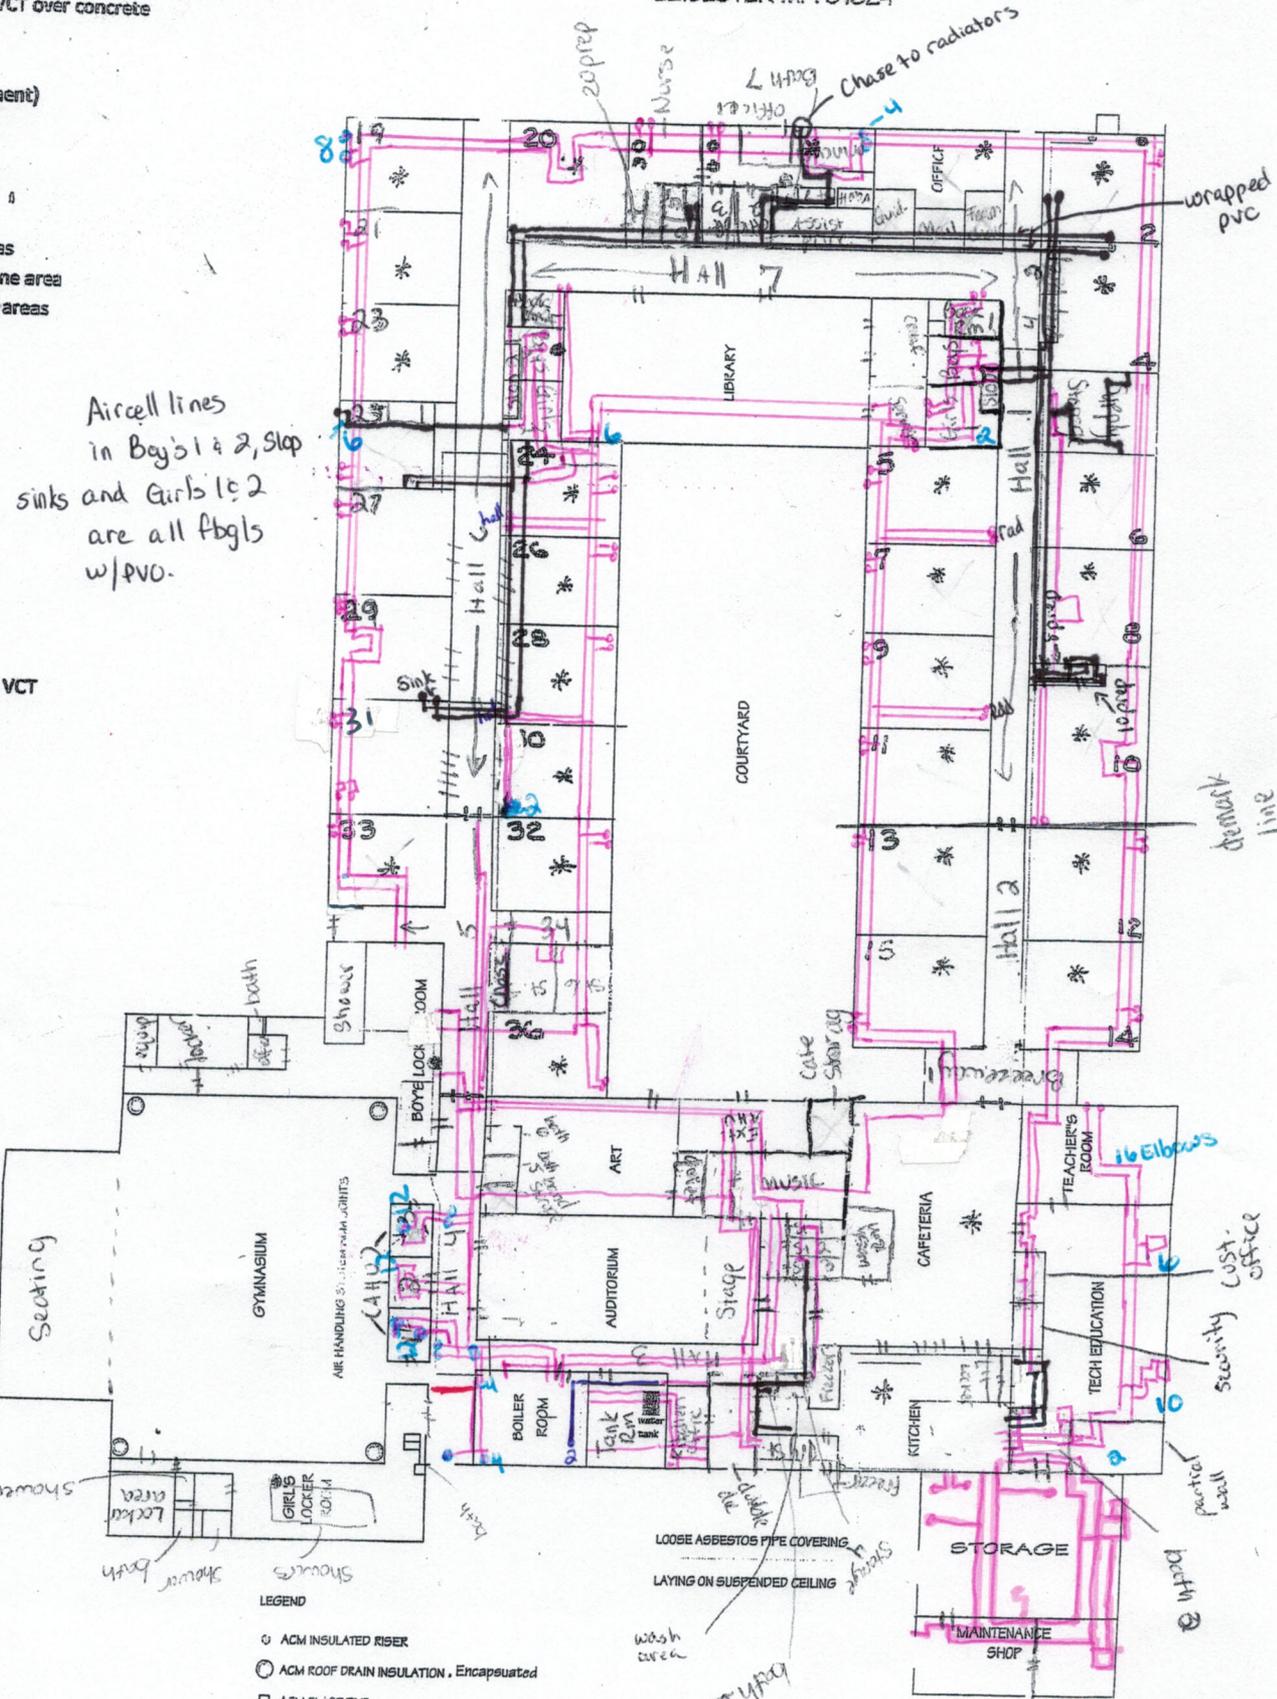
Aircell lines  
in Boy's 1 & 2, Slop  
sinks and Girls 1 & 2  
are all Abgls  
w/PVO.

wrapped in  
pvc

LOOSE ASBESTOS PIPE COVERING  
LAYING ON SUSPENDED CEILING

Above the ceiling in Hall 3, damage was noted to the paper wrap pipe insulation. This line should be repaired and the debris above the ceiling should be HEPA vacuumed and wet wiped. Ceiling tiles where debris was noted should then be replaced.
