Leicester Middle School  
70 Winslow Avenue  
Leicester, MA 01524

AHERA Three-Year Reinspection

April 2019

PROJECT: AHERA 3-Year Re-Inspection

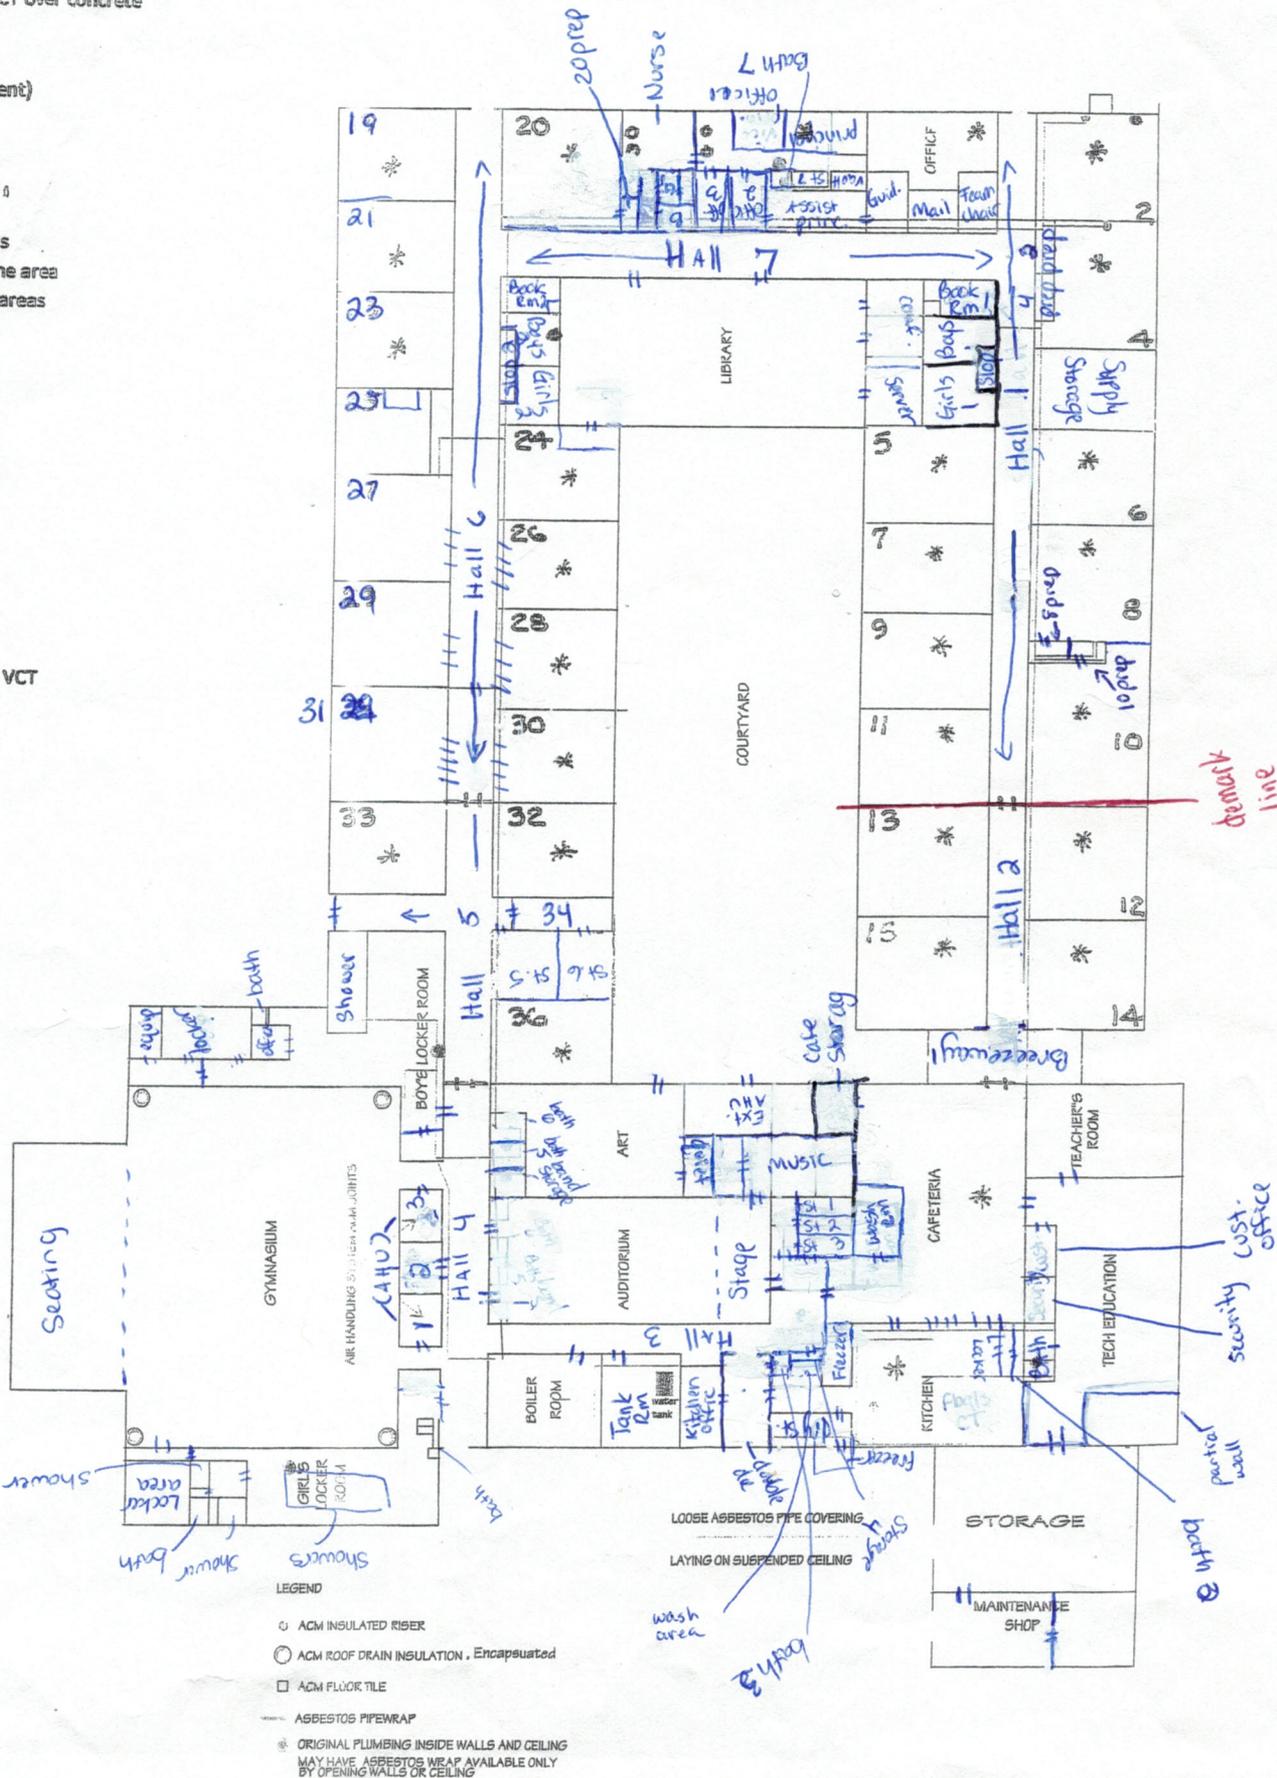
Auditorium  
 Carpet/concrete/VAT

## Tile Repair (replacement)

- Rm#25
- Rm#12
- Rm#13
- Rm#14
- Rm#15
- Rm#32
- Rm#33
- Rm#36

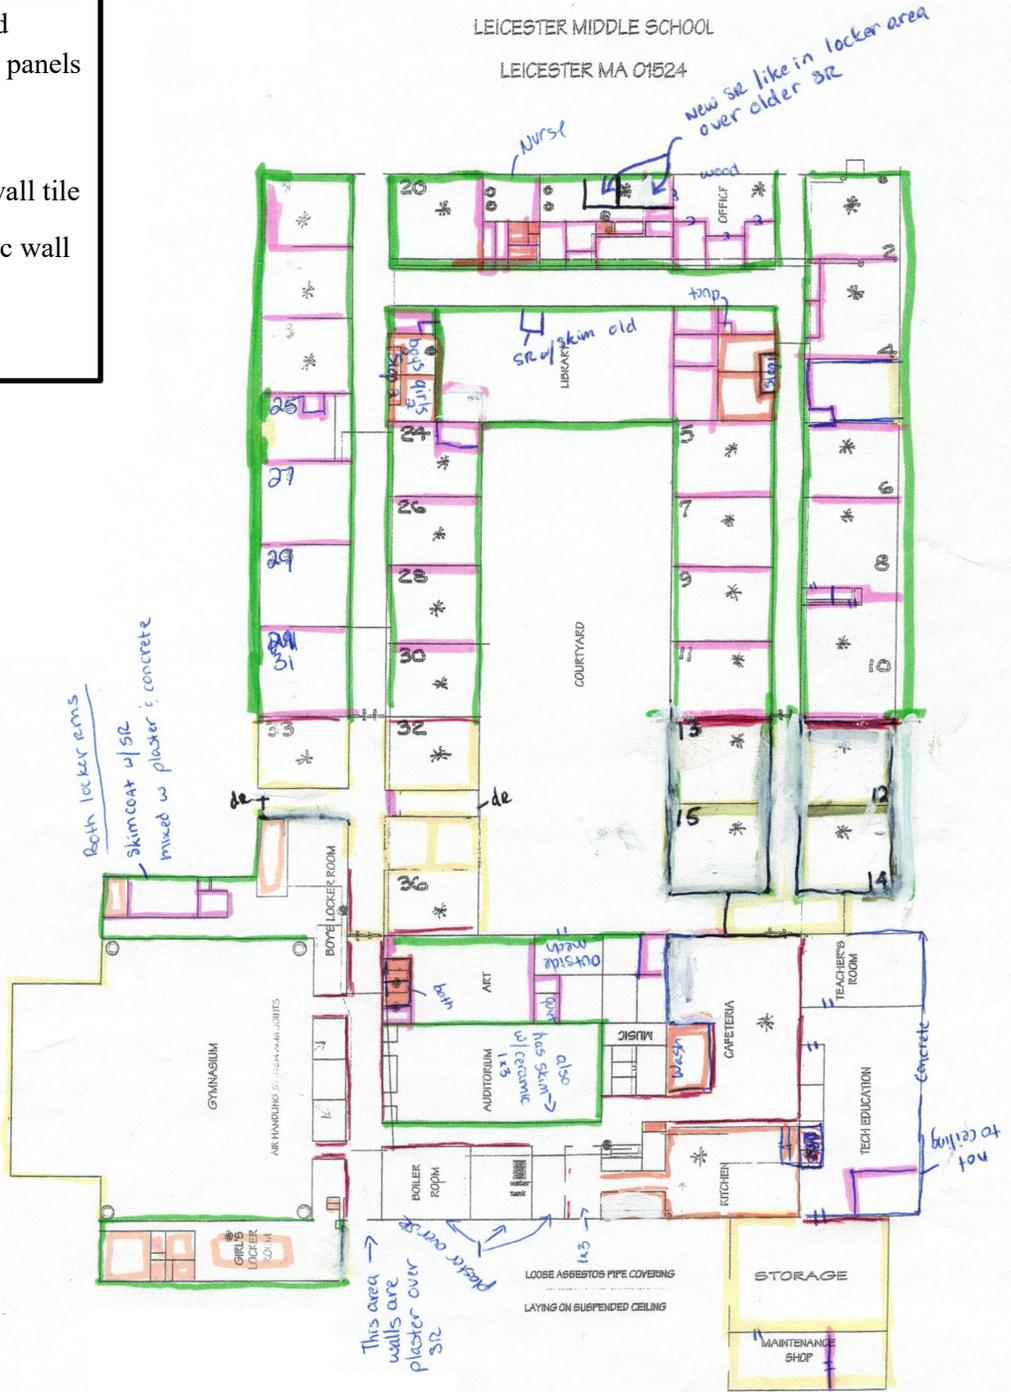
\*suspended ceiling

Academic wing corridors, cafeteria,  
Art Rm, Rm#4, #23, - VCT over VAT  
Library - carpet squares over VAT  
Ramped areas - 2 - VCT over concrete  
Office area - VAT

### Tile Repair (replacement)
